# RESTORATION OF A FORESTED WETLAND, STONE MOUNTAIN CREEK, DEKALB COUNTY, GEORGIA

James F. Renner

**REFERENCE:** *Proceedings of the 1991 Georgia Water Resources Conference*, held March 19 and 20, 1991, at The University of Georgia. Kathryn J. Hatcher, Editor, Institute of Natural Resources, The University of Georgia, Athens, Georgia, 1991.

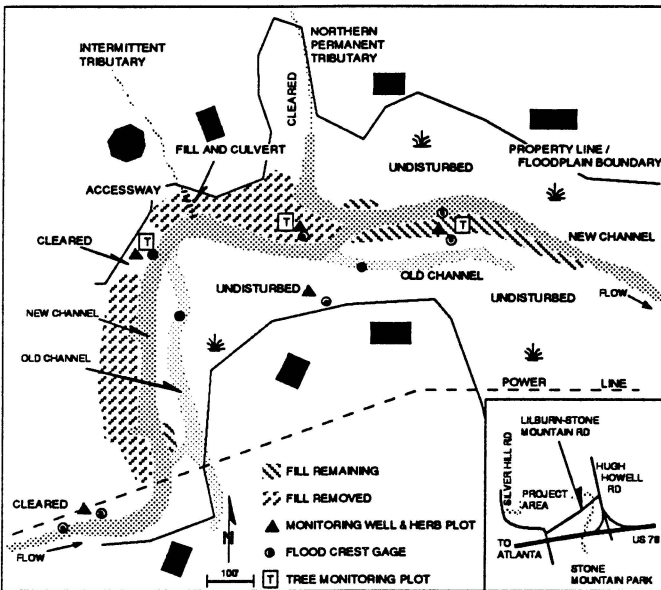
In April, 1990, implementation of the restoration plan began. Fill was removed from 1.1 acres on the northern and western banks of the creek (Figure 1). Excavation ceased as soon as the buried root mat was observed, because it was believed that the benefit of natural resprout would outweigh any adverse impact of incomplete fill removal. Where fill was removed, streambanks were graded to at least a 3:1 slope. The streambank along one section of undredged channel (power line right-of-way) also was graded in order to minimize erosion and allow increased floodwater conveyance. Difficulty arose when the adjacent landowner threatened to refuse further access. As a compromise, EPA approved spoil disposal in an intermittent tributary ravine. A culvert was installed, and the ravine was filled to a depth of about 5' with the remaining spoil. The banks were rip-rapped where the culvert emptied into the main creek channel. In areas where fill was allowed to remain, no grading or grubbing was implemented.

Figure 1. Stone Mountain Creek wetland restoration site. All disturbed areas were planted with trees except power line.
